ANALYSIS OF HUMAN ERRORS RELATED TO MANY MARINE ACCIDENTS OCCURRING WHILE ANCHORING AND MANOEUVRING AT AN ANCHORAGE

Grzegorz Rutkowski

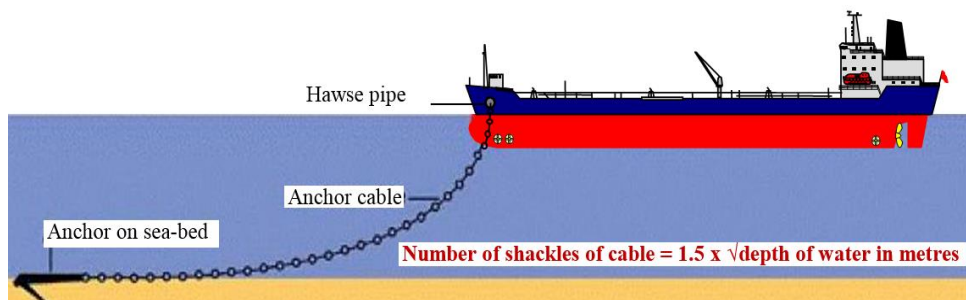
Fig. 1. To maximize an anchor's holding power; the cable length should be sufficient to ensure that, in fair weather, a length of cable will lie on the sea-bed and thus pull horizontally at the anchor shackle
