WORN-OUT STEAM TURBINE BODY OVERHAUL TECHNOLOGY

Abstract: The article presents the technology of overhauling a steam turbine body after prolonged operation at high temperatures. Before any repairs are made to such a body, preliminary material tests must be carried out, which will qualify it for scrapping or a revitalisation process, because the material undergoes degradation at creep temperatures. The purpose of the overhaul was to restore the steam turbine body (material grade L20HM) to operational condition.

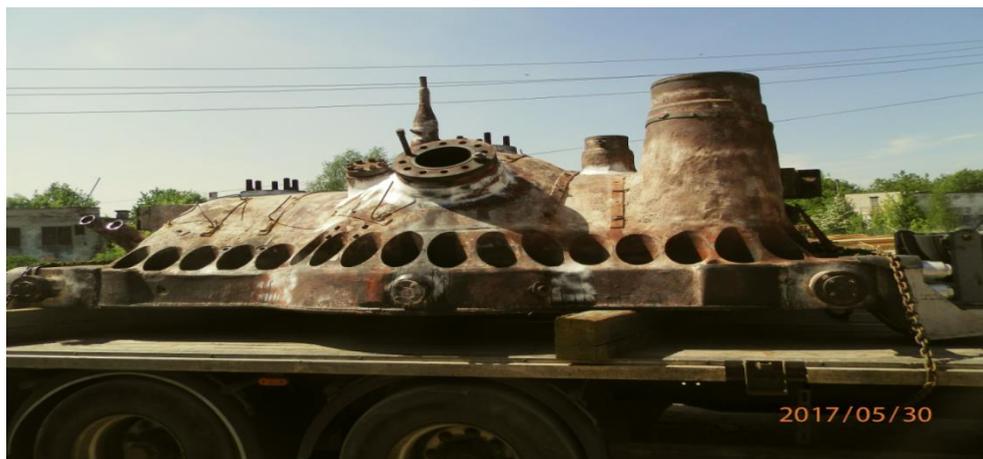
Figure 1 shows the lower part of the body after disassembly, condition as delivered.

Fig.1. Body of WP steam turbine for EC Gdynia TG1 as delivered after disassembly, lower part

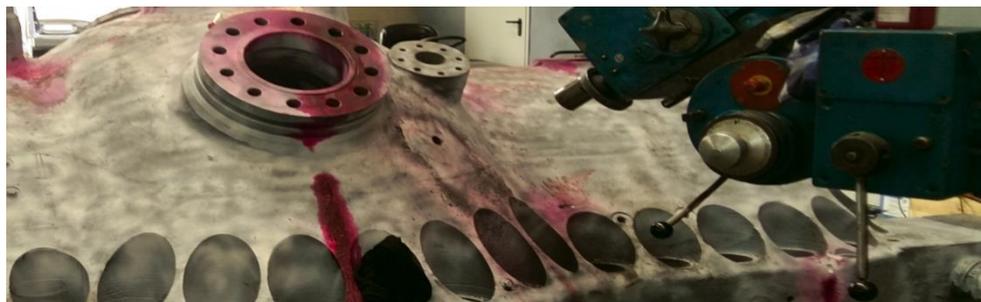
Samples for strength and microstructure testing from the hot areas in the upper and lower parts of the body were taken with a trepanning tool, and cold area samples were cut out [Wieczorska 2018].

Fig. 3. Location of 3LH sample collection — external WP body, lower part, hot area

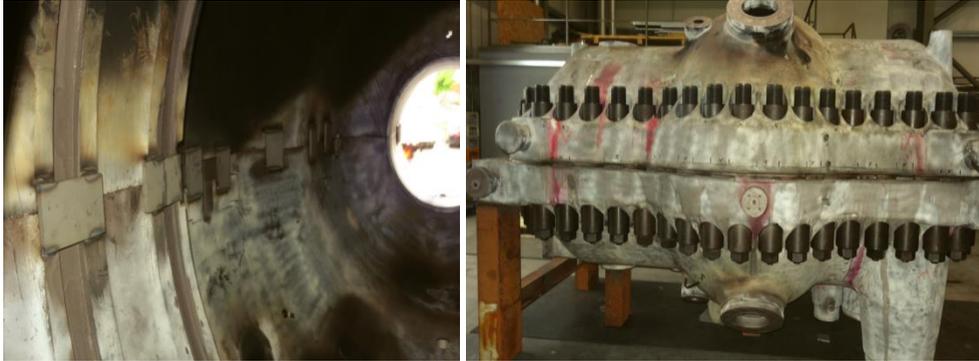
The first stage of the steam turbine repair process is a special heat treatment intended to dissolve carbides and enable repair by welding. However, before this stage was performed, both halves of the body had to be bolted together and braced, which was intended to protect the cast from major deformations during the heat treatment, as shown in Figure 6.

Fig. 6. Body preparation for heat treatment
